Arbor Court Outfall Repair

Location: End of SE Arbor Court

Project Type: Stormwater outfall repair

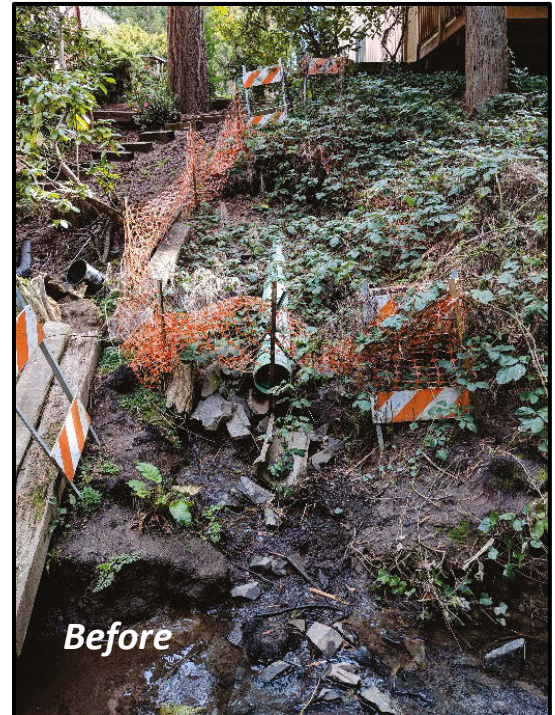
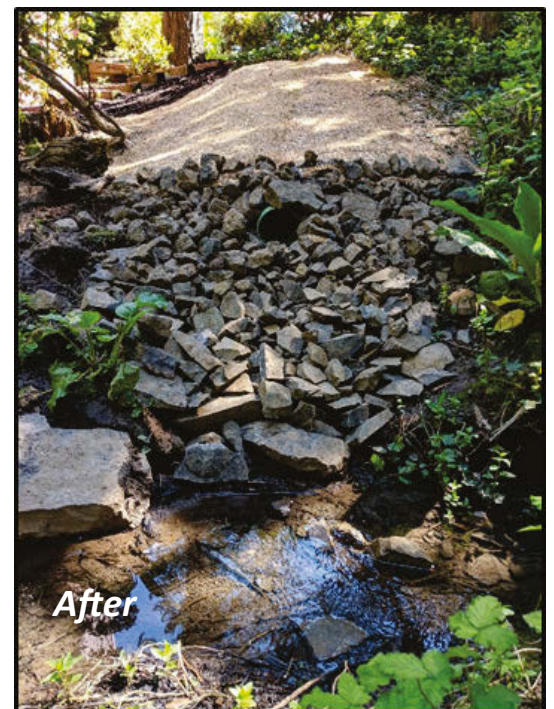
Purpose: The original outfall was built in 1972 to serve the Arbor Court cul-de-sac and part of SE 40th Avenue. The end of the outfall stormwater pipe collapsed and broke, causing erosion and unstable slopes adjacent to private property.

Repair: The outfall carved a deep channel down to Rock Creek, resulting in earth movement, erosion, and fallen trees.

- Installed 10 feet of new underground Stormwater pipe
- Added slope anchors to secure the new pipe in place
- Repaired and stabilized the bank
- Installed a new rock-lined channel
- Stabilized the site
