## **WATER MASTER PLAN UPDATE**

**CITY OF HILLSBORO WATER DEPARTMENT  
HILLSBORO, OREGON**

### **Final Report: Emergency Management / Seismic Resilience**

October 18<sup>th</sup>, 2018

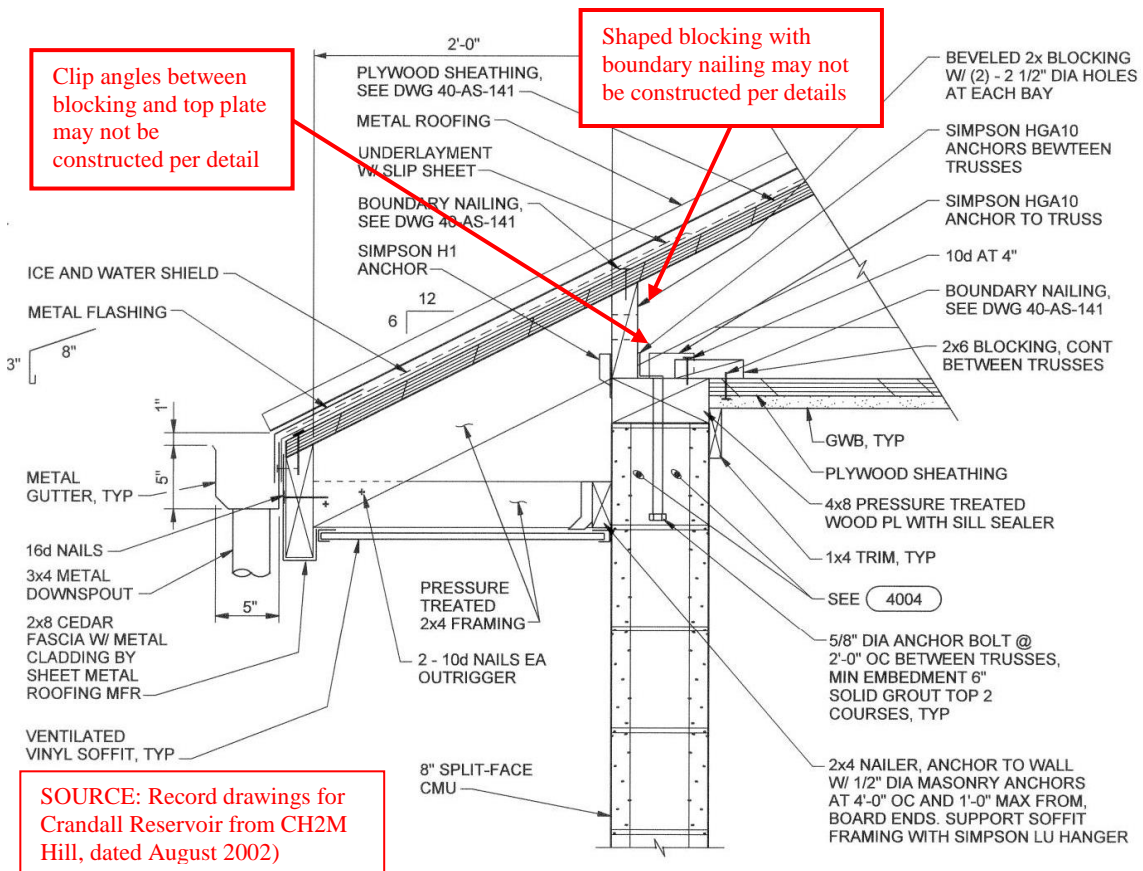
**Figure 7.3 – Evergreen Pump Station – Roof to Wall Connection**

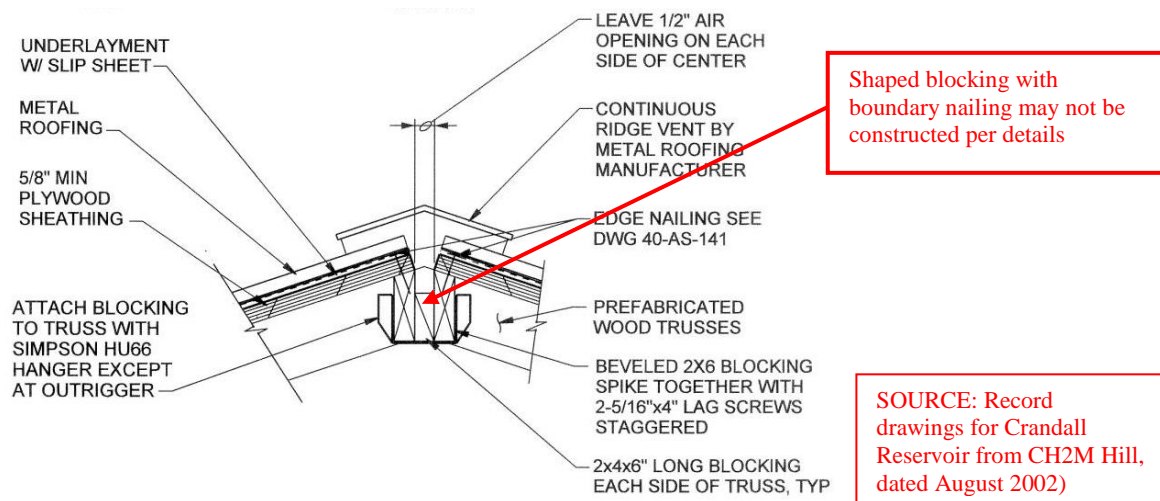
**Figure 7.4 – Evergreen Pump Station - Ridge Connection**

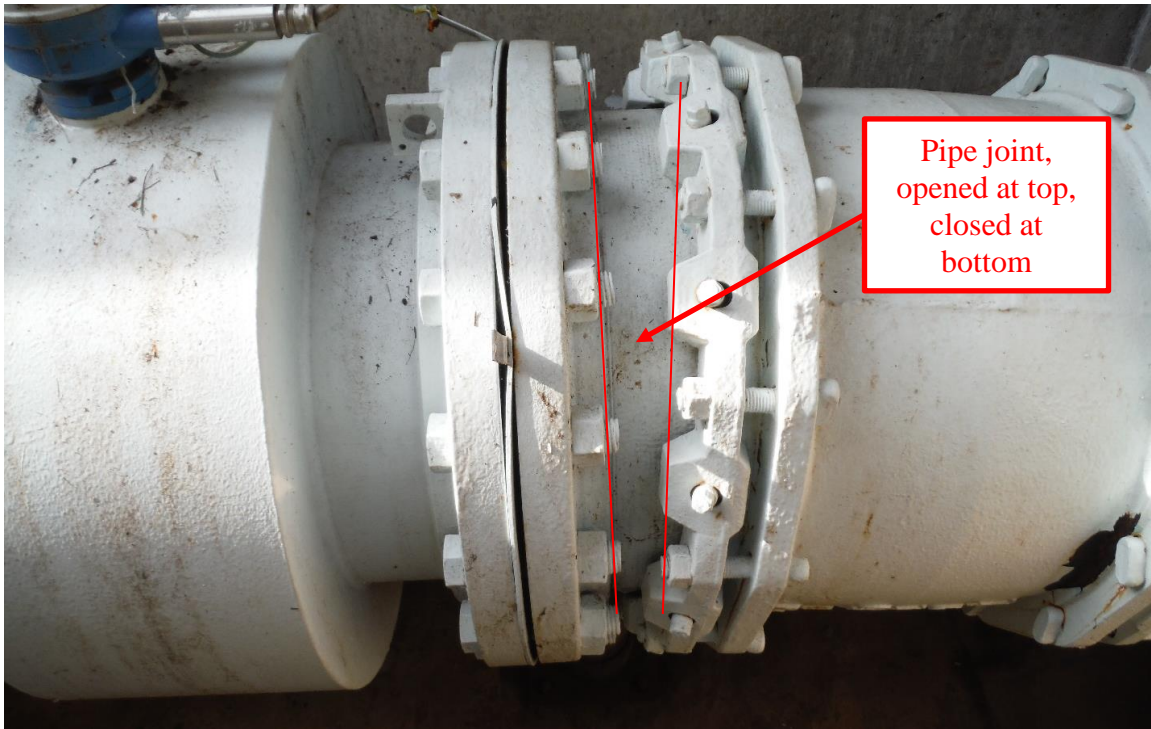
**Figure 8.3 – 25th Street PRV Vault - Flexible Joint with Capacity Exhausted**

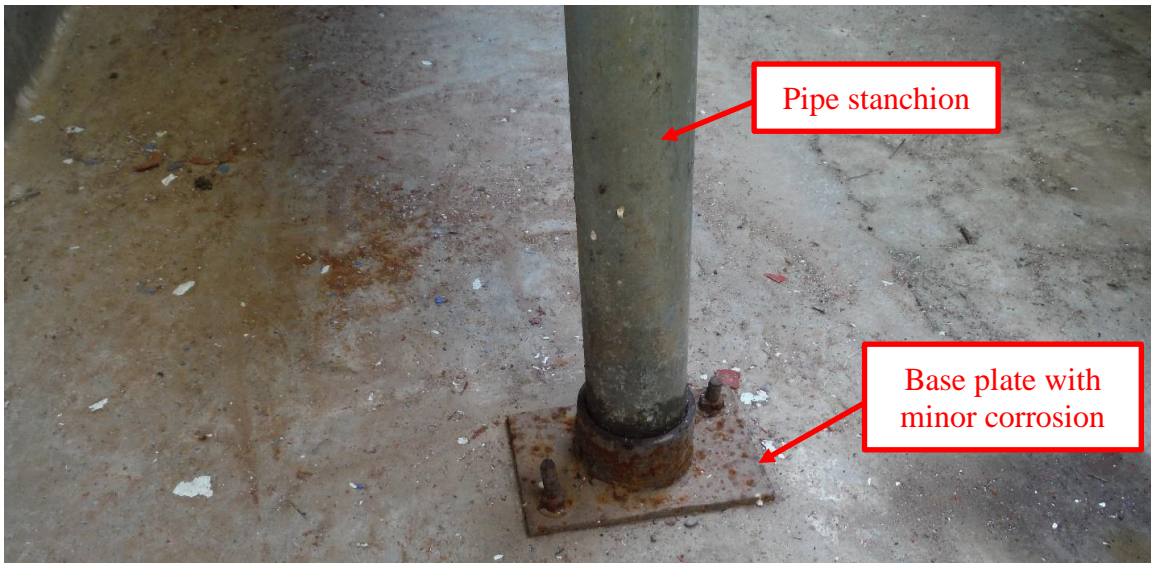
**Figure 8.4 – 25th Street PRV Vault - Base Plate with Minor Corrosion**

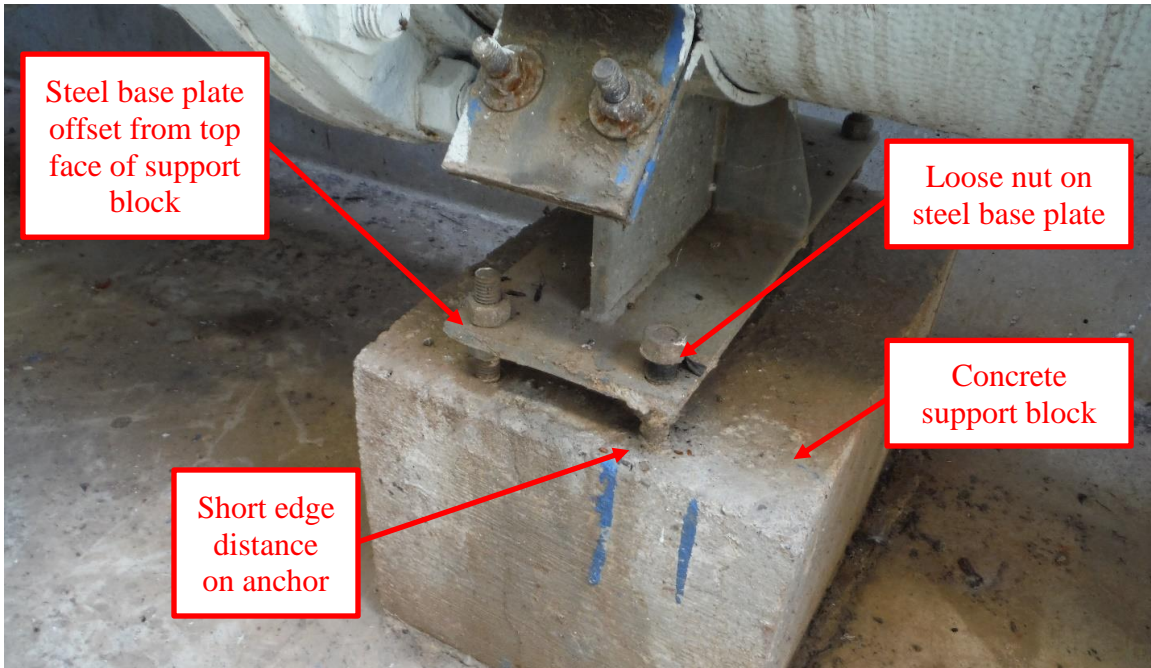
**Figure 8.5 – 25th Street PRV Vault - Ineffective Anchorage at Support Block**

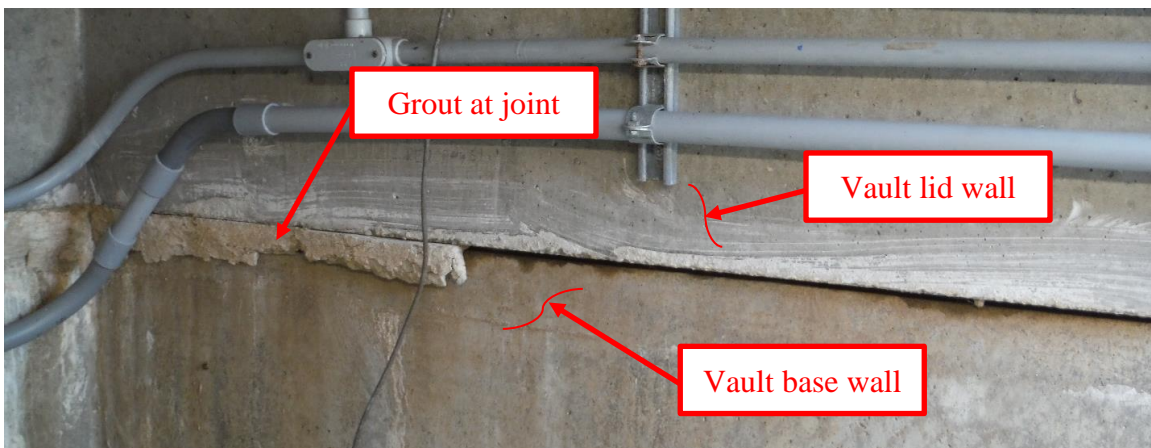
**Figure 8.6 – 25th Street PRV Vault - Vault Wall Joint**

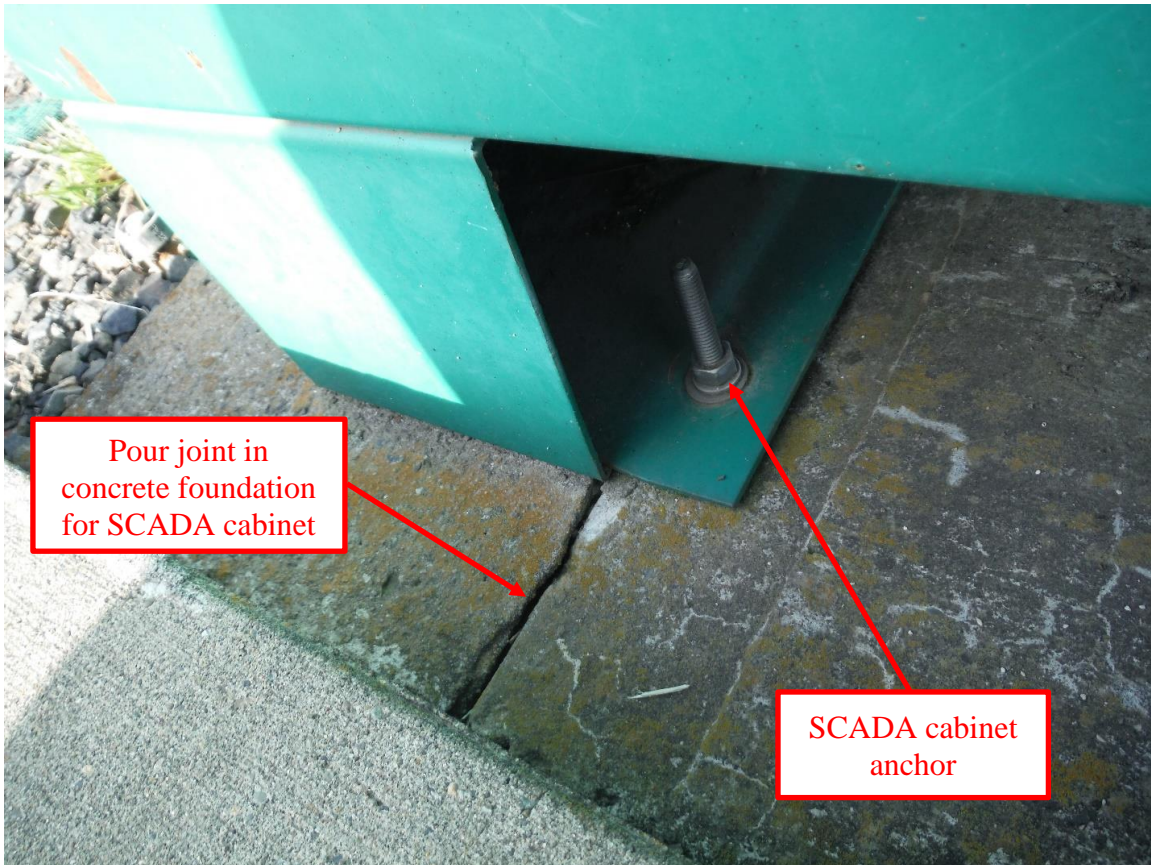
**Figure 8.7 – 25th Street PRV Vault - Segmented Foundation at SCADA Cabinet**

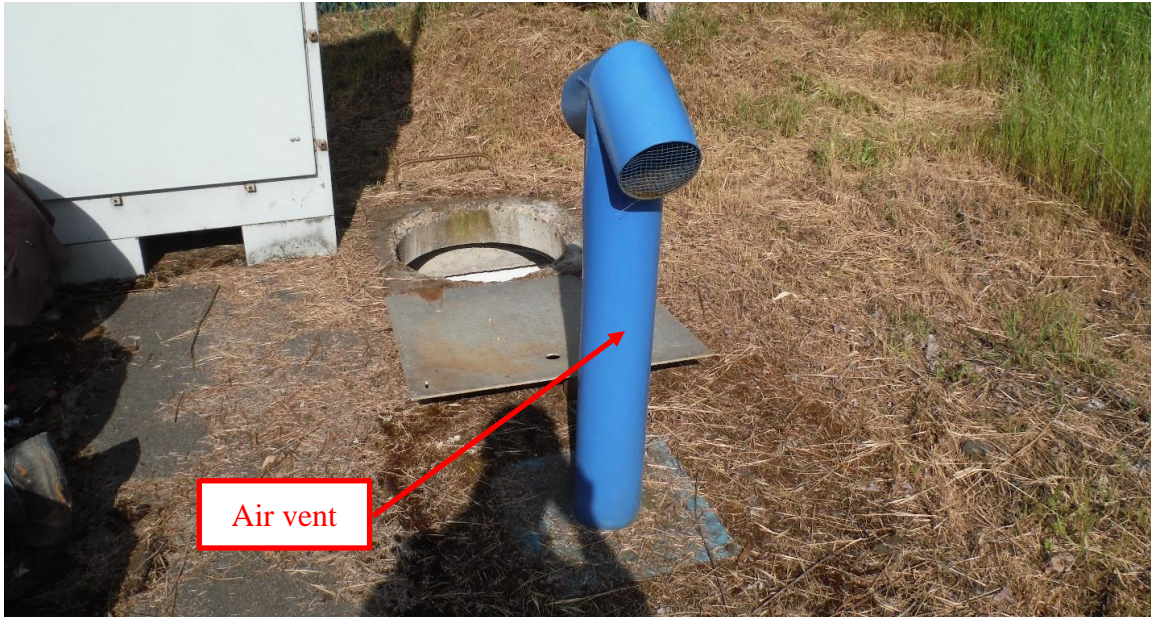
**Figure 8.10 – 1st Avenue PRV Vault - Air Vent Pipe**

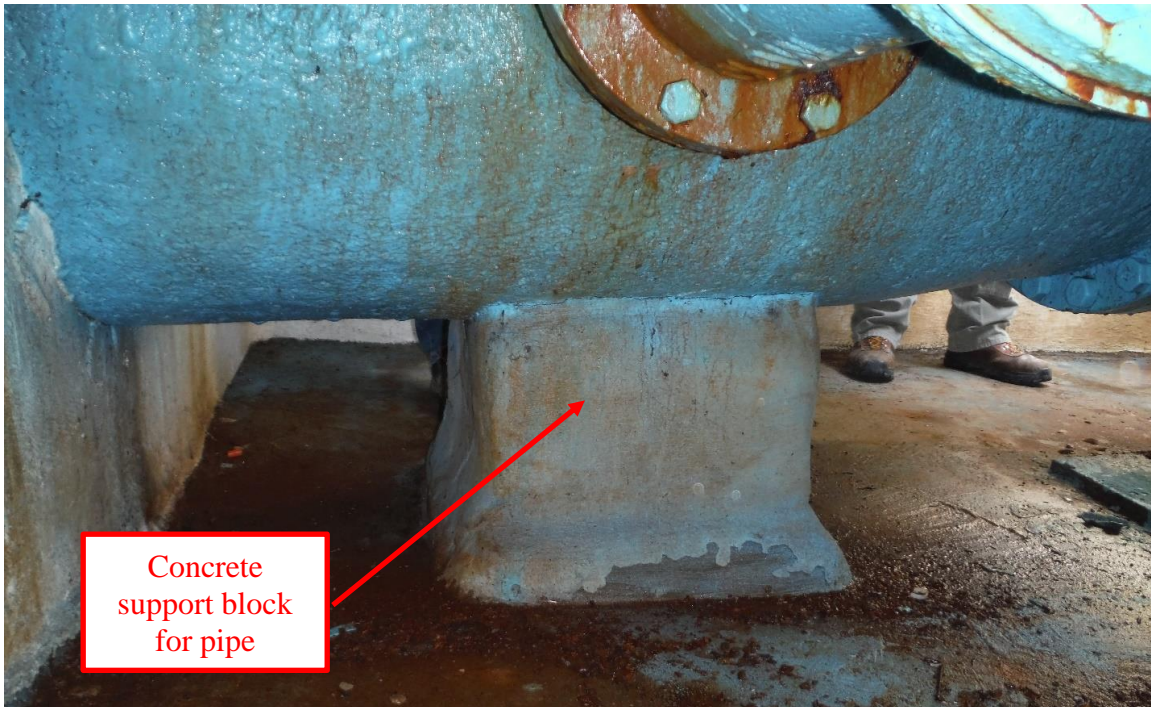
**Figure 8.11 – 1st Avenue PRV Vault - Concrete Support Block for Pipe**

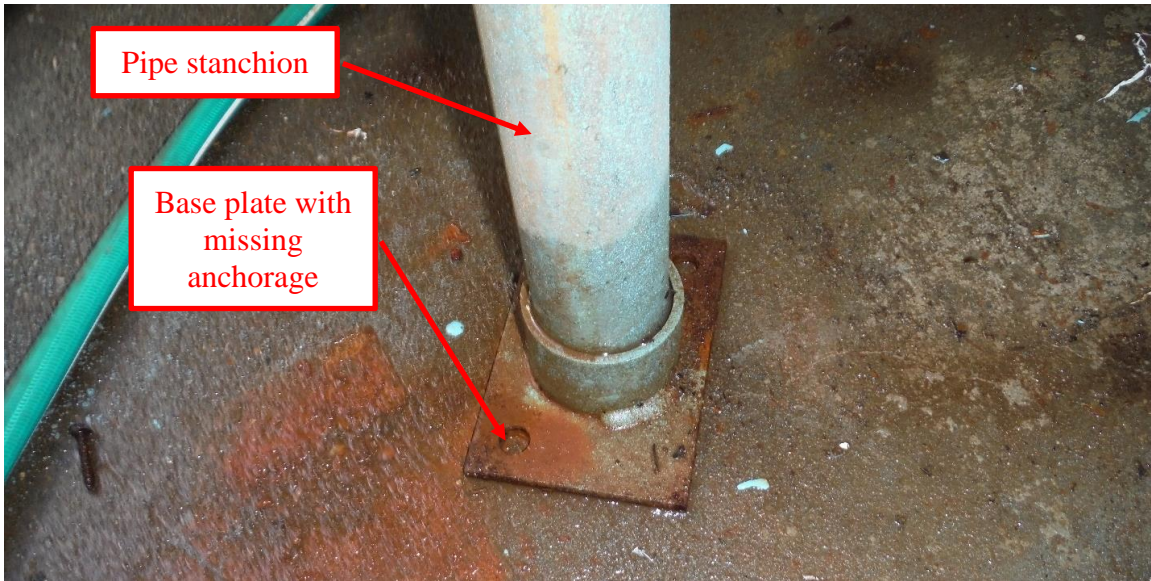
**Figure 8.12 – 1st Avenue PRV Vault - Pipe Stanchion Support**

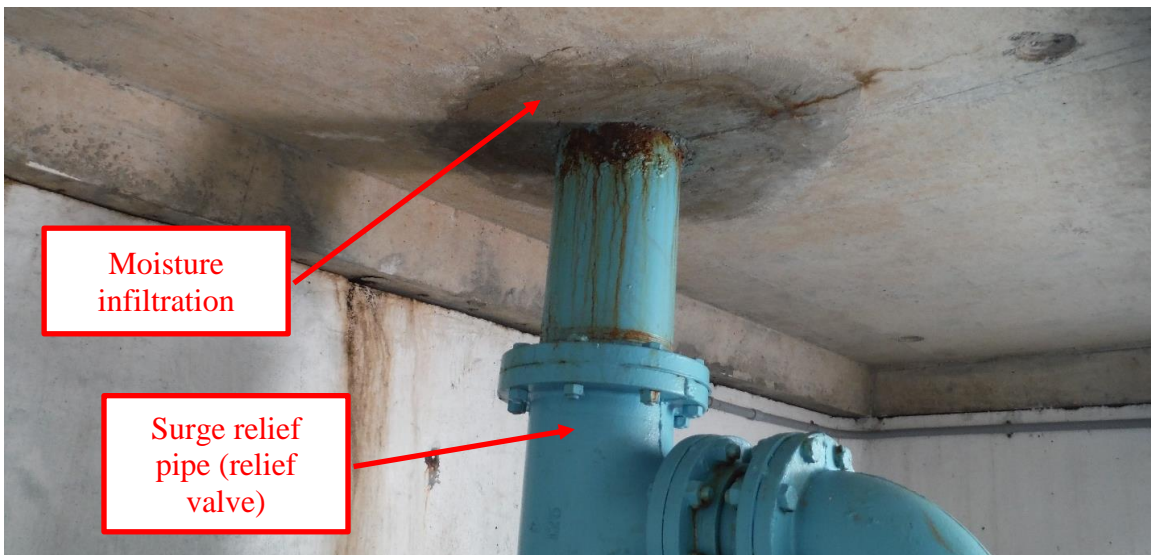
**Figure 8.13 – 1st Avenue PRV Vault - Surge Relief Pipe Penetration Through Vault Lid**

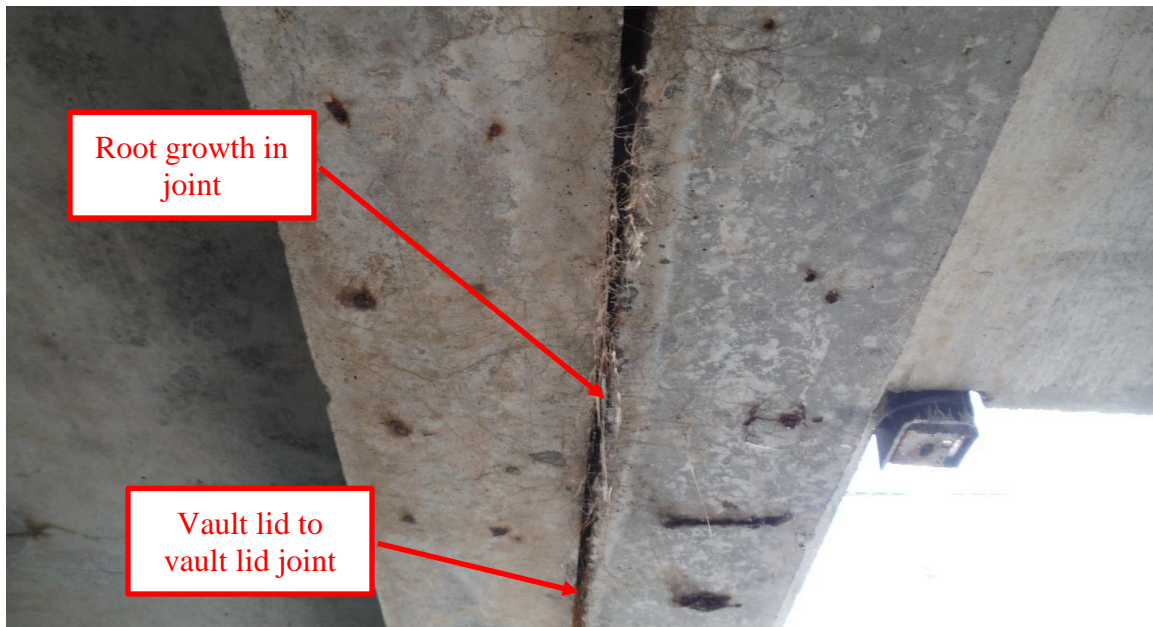
**Figure 8.14 – 1st Avenue PRV Vault - Vault Lid Joint**
