## Water Quality Facility #24

**Location:** Near SE Reedville Creek Drive at SE 69th Court

**Facility Type:** Extended dry basin

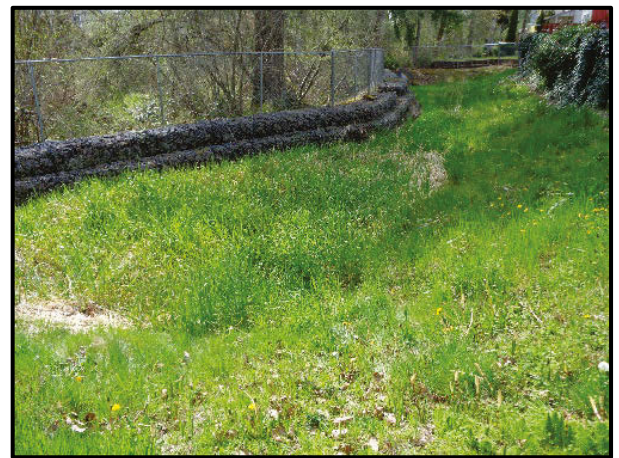
**Before:** Facility is overgrown and filled with heavy sediment.

**Repair:** Since 1996, the treatment area of the facility accumulated heavy sediment deposits, which prevented stormwater from correctly draining into the facility to receive treatment and storage during storm events. The repair process included:

- Removed sediment deposits, invasive plants, and volunteer trees
- Reestablished the treatment area
- Replaced the existing manhole with a new and larger water quality manhole to help capture future sediment deposits
- Planted new trees and water quality treatment plants

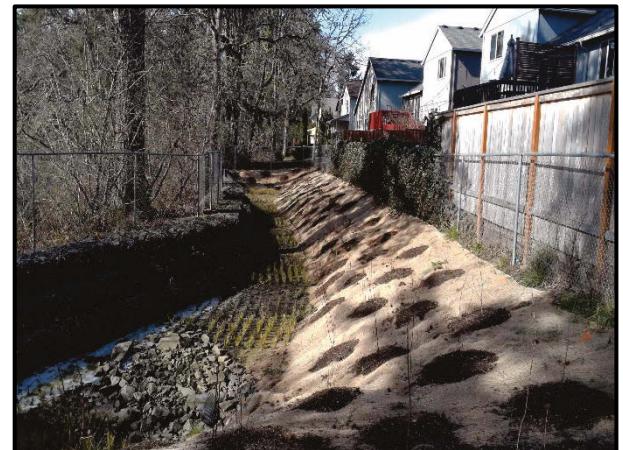
**After:** Facility was reshaped, planted, and rock was added. Photo was taken shortly after project completed.
