## **WATER MASTER PLAN UPDATE**

**CITY OF HILLSBORO WATER DEPARTMENT  
HILLSBORO, OREGON**

### **Final Report: Emergency Management / Seismic Resilience**

October 18<sup>th</sup>, 2018

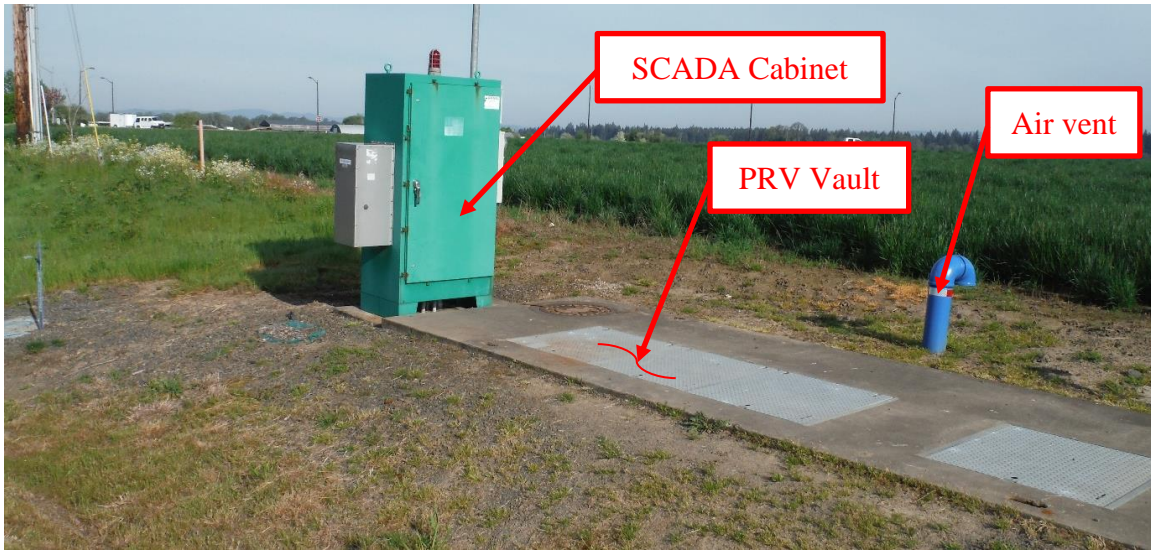
Potential Deficiencies	Description
<p align="center"><b>Seismic Structural</b></p>	<ul style="list-style-type: none"> <li>• Per Shannon &amp; Wilson Report: 1-12 inches liquefaction induced settlement, 6-24 inches liquefaction-induced lateral spreading, 0-0.1 feet earthquake-induced landslide PGD.</li> <li>• Joints of stacked precast valve vault construction may separate due to sliding forces associated with seismic lateral earth pressures on the face of the PRV Vault.</li> <li>• Sand, silt, or groundwater may infiltrate and leak into the PRV Vault at the precast concrete construction joint.</li> </ul>
<p align="center"><b>Seismic Nonstructural</b></p>	<ul style="list-style-type: none"> <li>• Relative movement between the PRV Vault structure and the adjacent soil may damage pipes.</li> <li>• The pipes and valves inside the PRV Vault are unbraced, except at the PRV Vault walls. Pipes may experience damage or fracture.</li> <li>• The observed flexible coupling, inside the PRV Vault, appears to have exhausted all its available rotational capacity.</li> <li>• The PRV is unbraced.</li> <li>• Pipe supports at the concrete piers exhibit several potential deficiencies. The base plate includes a stand-off from the top of the concrete pier that is not grouted, not all anchors are provided with sufficient edge distance within the concrete pier, and not all anchors include properly installed nuts.</li> <li>• Some pipe stanchions do not include anchors through the base plate into the vault base.</li> <li>• Separation of the PRV Vault lid and the PRV Vault base may result in damage to pipes and conduits that are anchored to both the base and the lid (e.g., surge relief pipe).</li> <li>• The SCADA cabinet is anchored to two concrete foundation segments, with some anchors ineffective as they are anchored into the joint between two foundation elements.</li> <li>• The UPS battery inside the SCADA cabinet is unbraced.</li> <li>• Equipment is likely not seismically certified to ensure functionality after a major earthquake.</li> </ul>

**Figure 8.1 – 25th Street PRV Vault - Overall View**

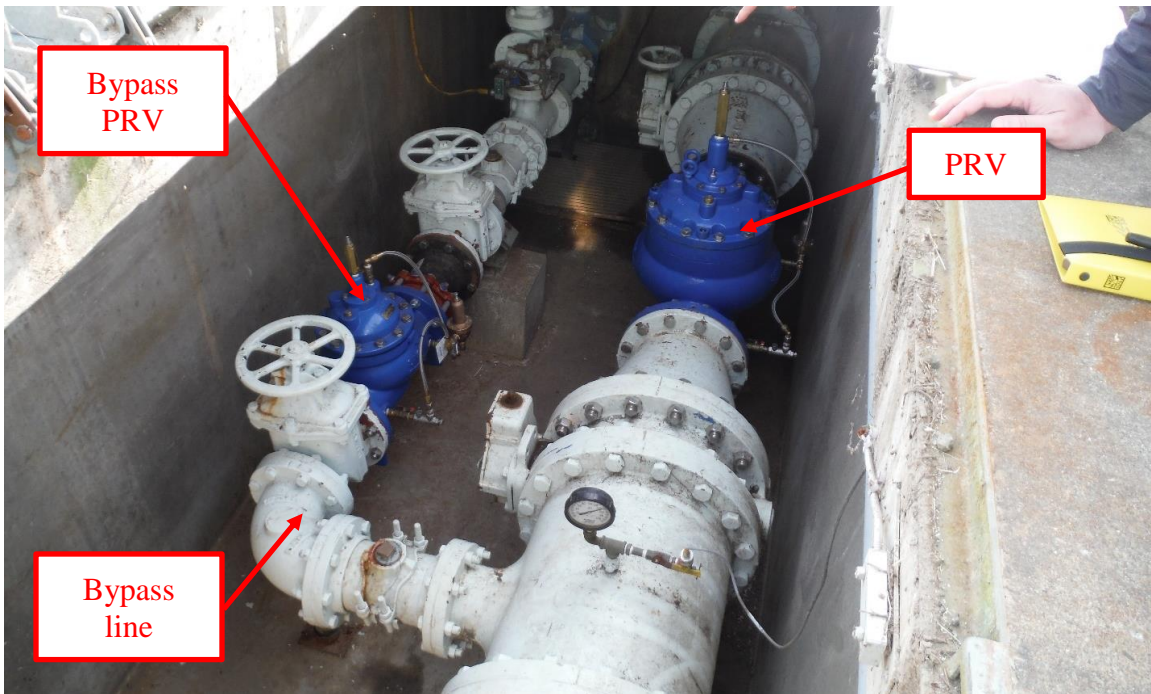
**Figure 8.2 – 25th Street PRV Vault - Interior Components**

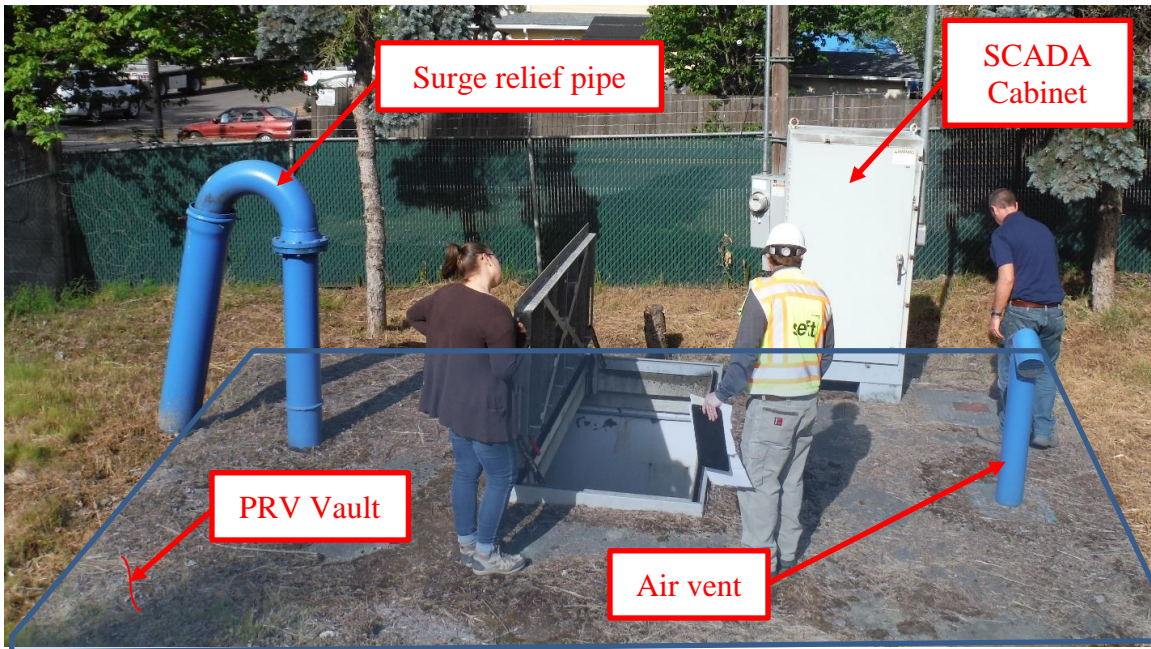
Potential Deficiencies	Description
<p align="center"><b>Seismic Structural</b></p>	<ul style="list-style-type: none"> <li>• Per Shannon &amp; Wilson Report: 3-12 inches liquefaction induced settlement, 12-24 inches liquefaction-induced lateral spreading, 0-0.1 feet earthquake-induced landslide PGD.</li> <li>• The joint between the cast-in-place PRV Vault wall and the precast valve vault lid may separate due to sliding forces associated with seismic lateral earth pressures on the face of the PRV Vault.</li> <li>• The PRV Vault lid does not have any interconnectivity between precast segments, resulting in an incomplete vault lid diaphragm.</li> </ul>
<p align="center"><b>Seismic Nonstructural</b></p>	<ul style="list-style-type: none"> <li>• Relative movement between the PRV Vault and the adjacent soil may damage pipes.</li> <li>• The pipes inside the PRV Vault are unbraced, except at the valve vault walls. Pipes may experience damage or fracture.</li> <li>• Pipe supports appear to lack the pipe to pipe support flat steel strap restraint that was shown in the original construction drawings.</li> <li>• Pipe stanchions at the vault base do not include anchors through the base plate into the vault base.</li> <li>• The PRV is unbraced.</li> <li>• Relative sliding between the PRV Vault lid and the valve vault base will result in damage to pipes and conduits that are anchored to both the base and the lid (for example the surge relief pipe).</li> <li>• Anchors for the air vent pipe above the PRV Vault have corroded to the point that the air vent pipe is unrestrained.</li> <li>• The section of surge relief pipe above the PRV Vault is unbraced.</li> <li>• Relative movement between the wooden access platform and the inlet pipe may fracture the pressure sensor at the south end of the PRV Vault.</li> <li>• Equipment is likely not seismically certified to ensure functionality after a major earthquake.</li> </ul>

Figure 8.8 – 1st Avenue PRV Vault - Overall View

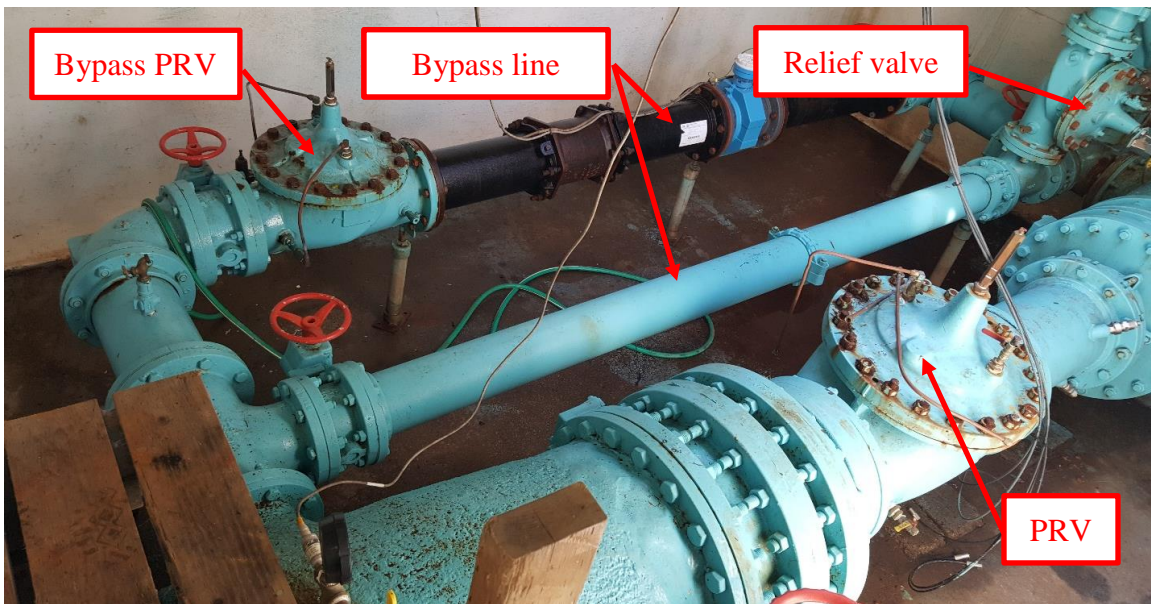
Figure 8.9 – 1st Avenue PRV Vault - Interior Components
