## Water Quality Facility #64

**Facility Type:** Vegetative swale

**Purpose:** Built in 1999, the facility treats stormwater runoff from the Alderbrook residential subdivision and drains to McKay Creek.

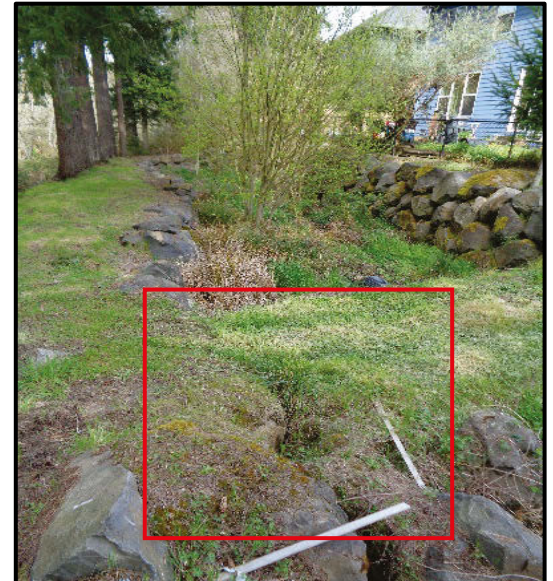
**Repair:** The swale was not working correctly due to an underground sanitary line crossing several feet below the facility. The underground crossing created depressions within and adjacent to the treatment area which prevented the facility from functioning as originally designed.

**Before:** red box indicates the depression in the ground.

- Removed invasive plants, volunteer trees, and sediment deposits
- Excavated and backfilled the depression areas with clay and native soil
- Placed rock and restored the original swale profile
- Restored the outfall pad with new rock
- Planted new trees and water quality treatment plants

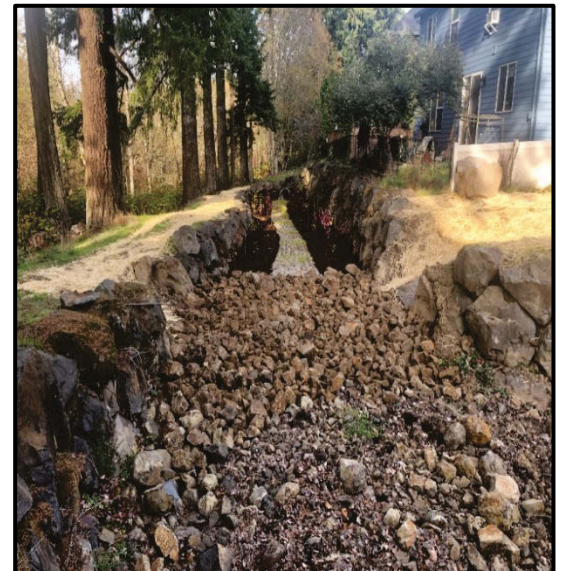
**After:** Depression is rocked and the swale is replanted.
